WOOD DESTROYING PESTS AND ORGANISMS INSPECTION REPORT

Building Address: 375 W 24th St., San Bernardino, CA 92405		Date of Inspection 10/20/2015	Number of Pages 6

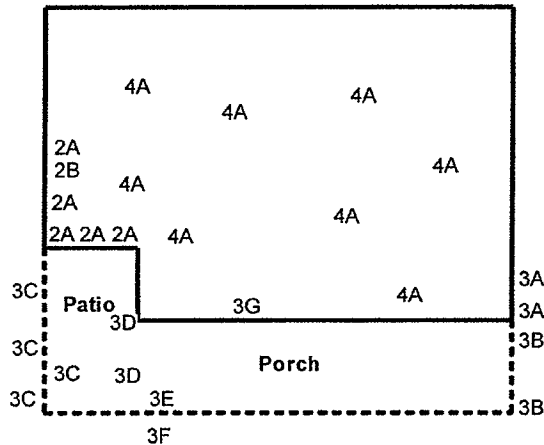
Other Tags Posted: None	
An inspection has been made of the structure(s) shown on the diagram in accordance with the Structural Pest Control Act. Detached porches, detached steps, detached decks and any other structures not on the diagram were not inspected.			
Subterranean Termites <input type="checkbox"/> Drywood Termites <input checked="" type="checkbox"/> Fungus / Dryrot <input checked="" type="checkbox"/> Other Findings <input type="checkbox"/> Further Inspection <input type="checkbox"/> <small>If any of the above boxes are checked, it indicates that there were visible problems in accessible areas. Read the report for the details on checked items.</small>

This Diagram is not to scale
